**Flood Control Project Maintenance  
Levee Inspections**

**Fall 2011 Levee Maintenance Deficiency Summary Report**

**Solano County Public Works Mellin Levee**

**Levee Inspection Report By Mile - Fall 2011**

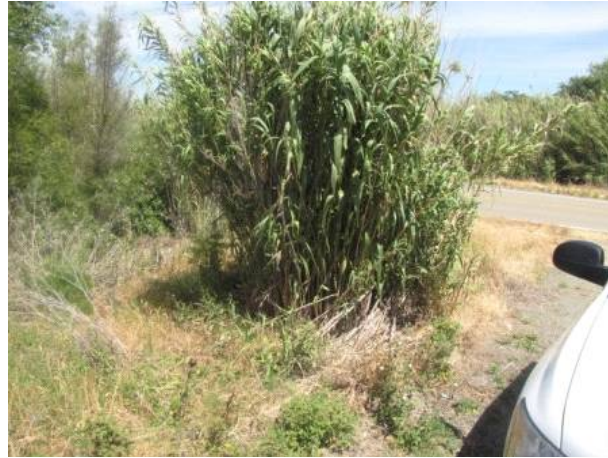
Levee Mile Report Line	1
Start Levee Mile	0.00
End Levee Mile	0.00
Location	Water Side
Category	Earthen Levee
Item	Vegetation

Looking northeast at bamboo on waterside at the entrance to levee.

LMR No.	Levee Mile		Category	Item	Location *	Rating **	Action/Comment	GPS Latitude/Longitude		Issue No.
	Start	End						Start	End	
1	0.00	0.00	Earthen Levee	Vegetation	WS	M	Remove the wild growth other than native grasses from the levee slopes. Inspector Comments: Bamboo on waterside slope	38.174051 ° -121.674220 °	38.174051 ° -121.674221 °	1 Y
2	0.00	0.59	Earthen Levee	Encroachments	WS	PO	Fences	38.174167 ° -121.674312 °	38.178960 ° -121.680600 °	3 Y
3	0.02	0.59	Earthen Levee	Crown Surface / Depressions / Rutting	CR	C	Keep the crown roadway free of vegetation.	° °	38.180033 ° -121.681957 °	12
4	0.04	0.04	Earthen Levee	Encroachments	LS	M	Abandoned vehicles	38.174470 ° -121.674730 °	38.174470 ° -121.674730 °	8 Y
5	0.08	0.08	Earthen Levee	Slope Stability	WS	C	Repair the levee slope damaged by foot traffic and prevent access where possible.	38.174948 ° -121.675263 °	38.174948 ° -121.675263 °	2
6	0.10	0.28	Earthen Levee	Encroachments	LS	PO	Fences	38.175115 ° -121.675463 °	38.176805 ° -121.677893 °	4

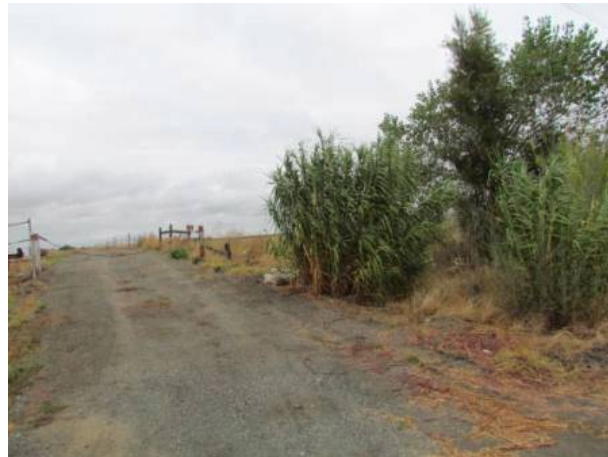
Levee Mile Report Line	1
Start Levee Mile	0.00
End Levee Mile	0.00
Location	Water Side
Category	Earthen Levee
Item	Vegetation

Looking west at bamboo on waterside slope.

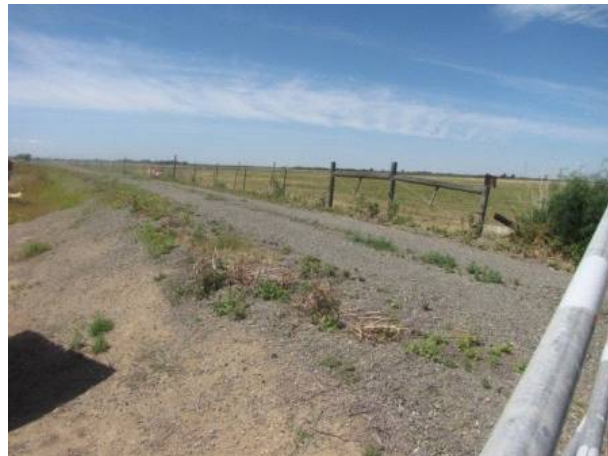
Levee Mile Report Line	2
Start Levee Mile	0.00
End Levee Mile	0.59
Location	Water Side
Category	Earthen Levee
Item	Encroachments

Fence along the waterside shoulder.

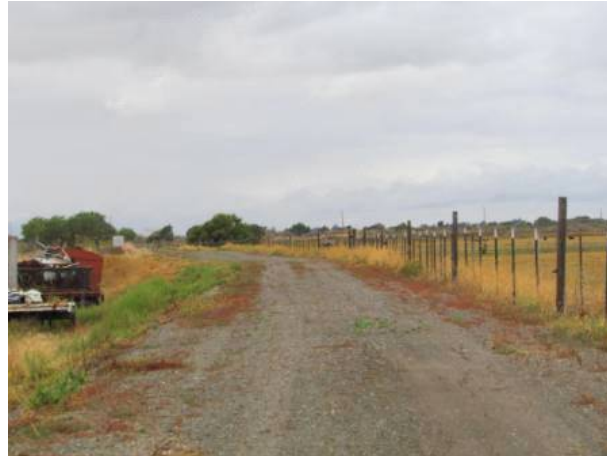
Levee Mile Report Line	2
Start Levee Mile	0.00
End Levee Mile	0.59
Location	Water Side
Category	Earthen Levee
Item	Encroachments

Looking west at fence along waterside shoulder.

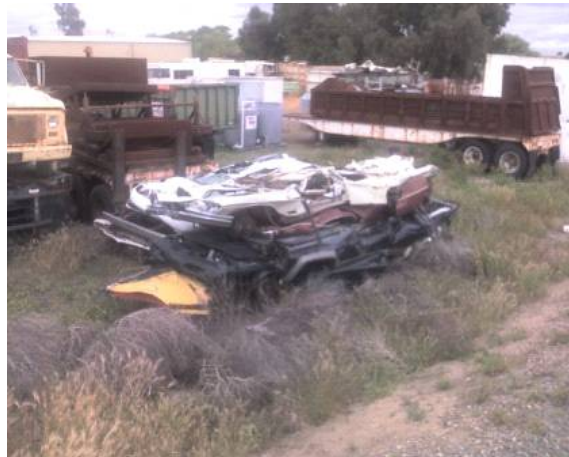
Levee Mile Report Line	4
Start Levee Mile	0.04
End Levee Mile	0.04
Location	Land Side
Category	Earthen Levee
Item	Encroachments

Looking southwest at dilapidated vehicles on landside toe.

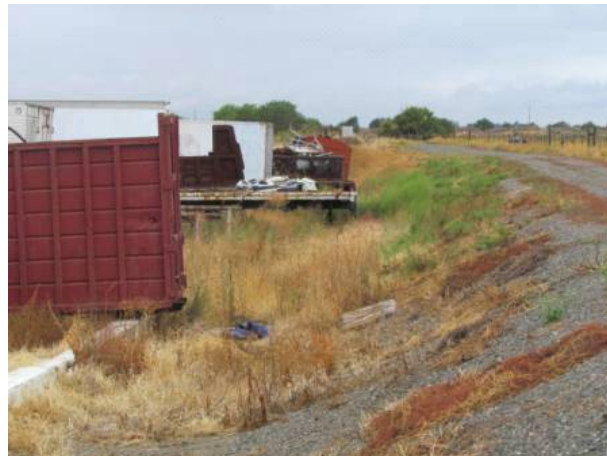
Levee Mile Report Line	4
Start Levee Mile	0.04
End Levee Mile	0.04
Location	Land Side
Category	Earthen Levee
Item	Encroachments

Looking west at equipment along landside toe.
